Civil Works for Hydroelectric Facilities

Guidelines for
Life Extension
and Upgrade

PREPARED BY
Hydropower Task Committee of the Energy Division of
the American Society of Civil Engineers

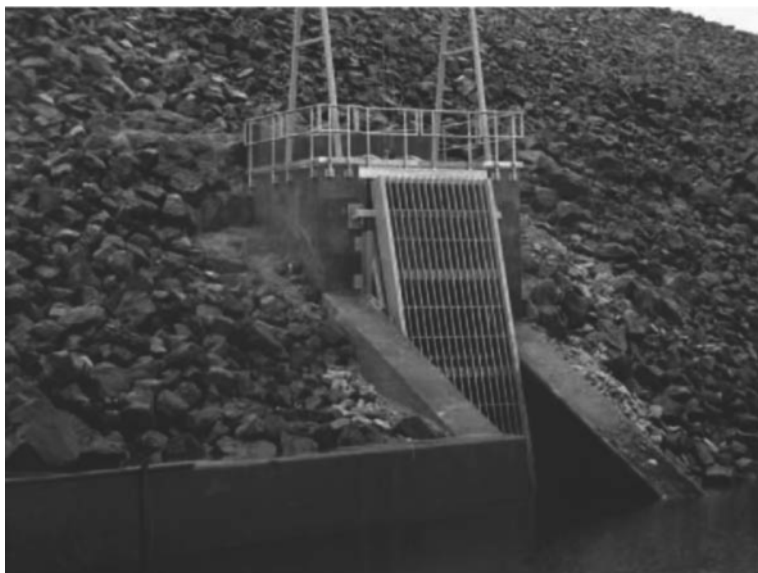
**Figure 4.2-2 New Intake Tower, Gate and Trashrack Installed Upstream of LLO, Elsie Dam
(courtesy of BC Hydro)**

The existing LLO, the proposed upgrades and photographs taken during the construction of the improvements to the LLO are shown in Figure 4.2-4 and 4.2-5.

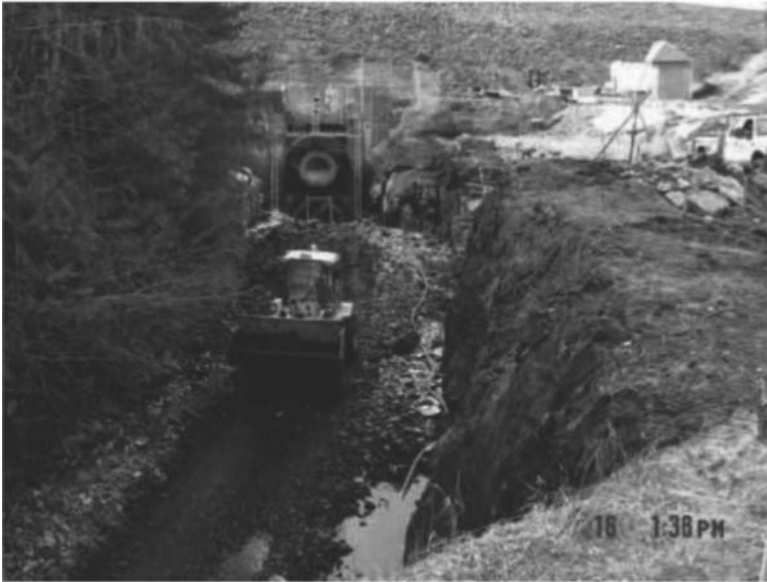
Figure 4.2-3 New Conduit Liners Before Installation Inside the Old Liner (courtesy of BC Hydro)

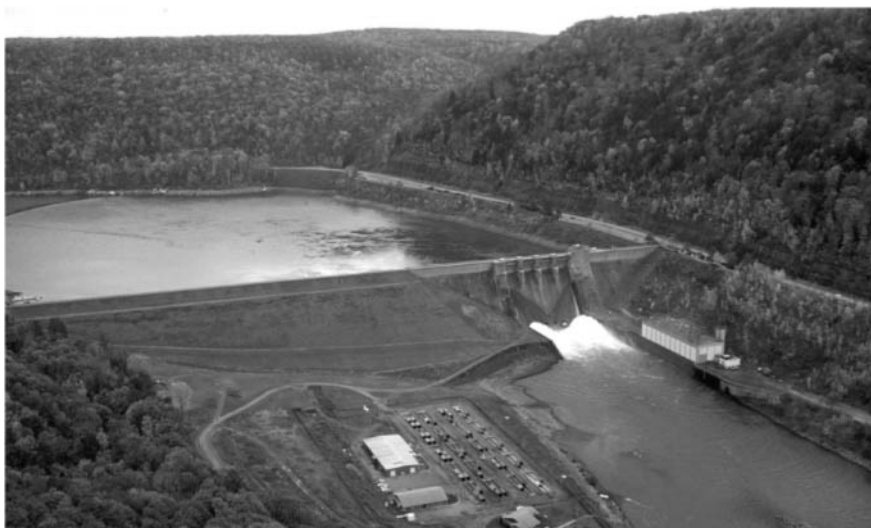
Figure 4.3-1 Kinzua Dam
(courtesy of Portland District, USACE)

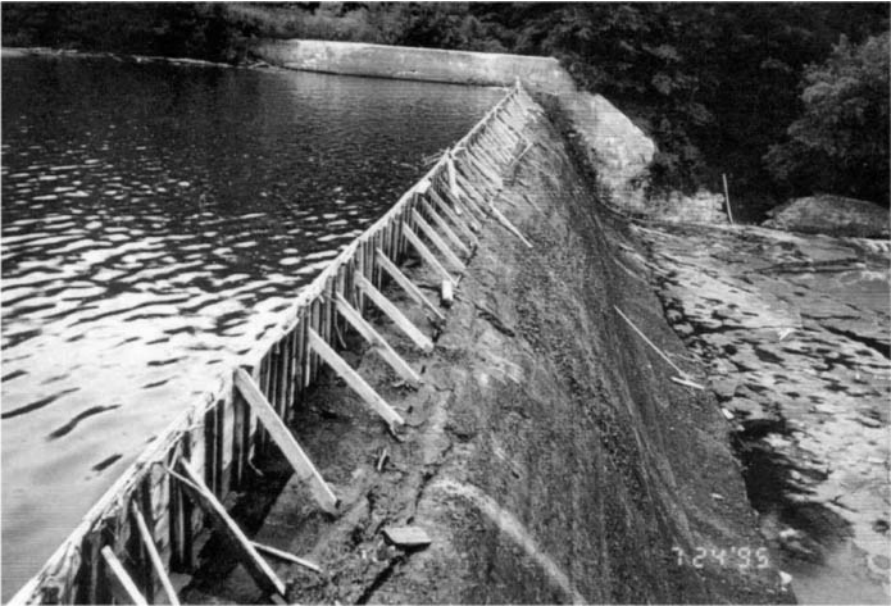
Figure 4.3-2 Inghams Spillway Deterioration
(courtesy of Brookfield Power New York)

In 1997, the condition of the spillway was considered poor (Figure 4.3-2). Its defects included: cracked concrete, deep gouges in the surface especially near joints, concrete spalling as deep as 12 inches, undermining of the toe, and 54-inch high wooden flashboards that were unreliable and expensive to replace on average twice per year. These were the main reason for significant upstream pond fluctuations and resident complaints.

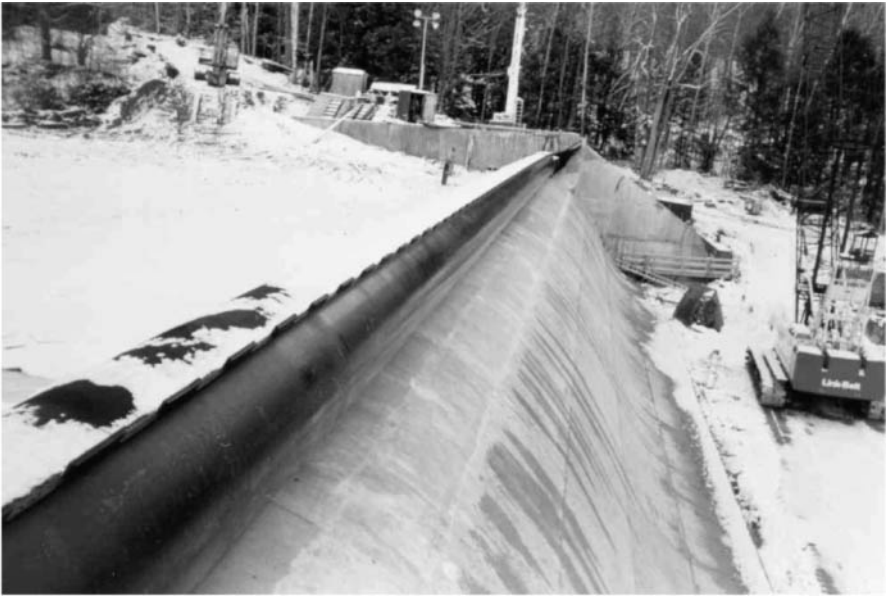
Figure 4.3-3 Inghams Rebuilt Spillway
(courtesy of Brookfield Power New York)

Major rehabilitation of the spillway was performed in 1997, and included removal and replacement of a minimum 8 inch thickness of reinforced concrete from both abutments, the spillway crest, spill surface, toe, and portions of the upstream face; reconstruction of the undermined areas of the spillway toe; installation of a new 54-inch high inflatable crest control system (rubber dam) with local controls, and erection of a fall protection cable to which personnel could attach for safety when accessing the spillway crest (Figure 4.3-3).

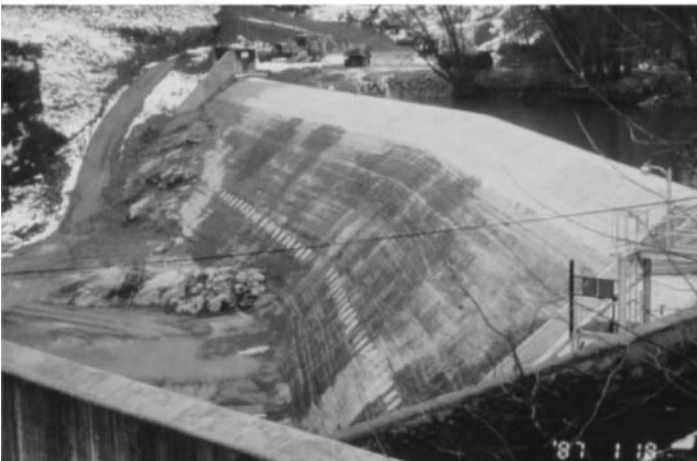
Figure 4.3-4b Niagara After Remediation
(courtesy of American Electric Power)

Two options were considered for remediation of the spillway. The first option was to buttress the downstream face with grouted riprap, and the second option was to use roller-compacted concrete (RCC). The second option was selected using RCC with a two-foot sacrificial outer surface and a conventional concrete cap. The RCC option was selected because regulating agencies had concerns regarding quality control in

constructing, and longevity of the grouted riprap option. Figures 4.3-4a and 4.3-4b show the Niagara Project before and after the remediation.

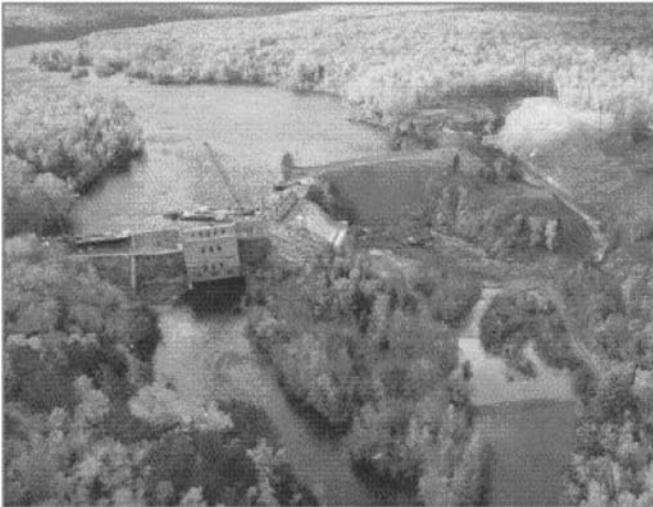
Figure 4.3-5 Brule Dam
(courtesy of MWH)

Ultimately, Brule Dam, a 60-foot-high combination earthfill and concrete dam constructed in 1916, was identified as a priority project for corrective action. The 50% PMF was selected as the appropriate inflow design flood. Design work was initiated and completed for rehabilitation of the existing tainter gate controlled spillway, including concrete resurfacing at the Brule Dam. In addition, a new, two-stage, fuse-plug controlled, side channel auxiliary spillway was designed and constructed in rock around the left abutment of the main earth embankment to solve the spillway capacity problems.

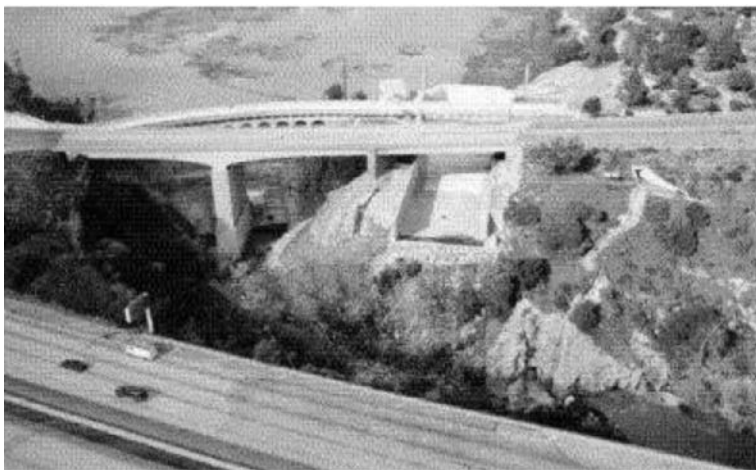
Figure 4.3-6 Devil's Gate Dam
(courtesy of MWH)

Devil's Gate Dam, completed in 1920, is a 103-ft high concrete-gravity arch dam located near Pasadena, California. Its primary purpose is flood and debris control. Owned by the Los Angeles County Department of Public Works, prior to rehabilitation, the reservoir had been restricted by the State of California, Division of Safety of Dams (DSOD), due to stability concerns during a seismic event, and because of inadequate spillway capacity to pass the runoff resulting from the Probable Maximum Precipitation (PMP) event.

Five spillway expansion alternatives were prepared, with the final spillway capacity increase achieved by replacing the existing ungated spillway with an orifice and overflow spillway headworks and a new reinforced concrete spillway chute.

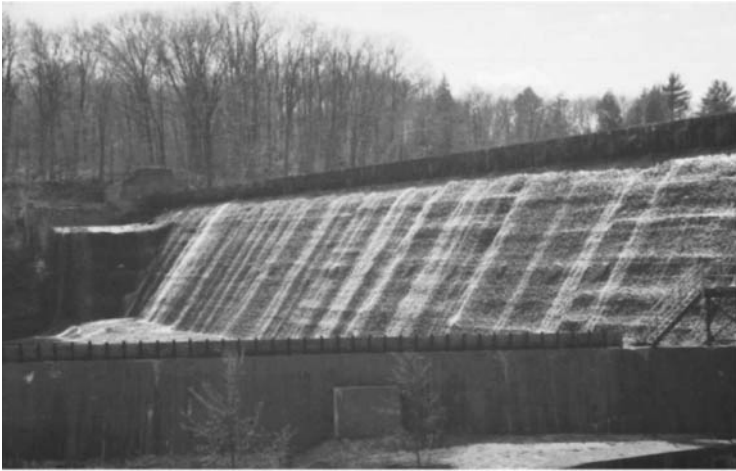
Figure 4.3-8 Rainbow Dam
(courtesy of Kleinschmidt Associates)

Monitoring of the spillway dam had determined that the structure had lost an average of six to eight inches of concrete from the surface of the dam (see Figure 4.3-8). While sub-freezing conditions are common in Connecticut, the deterioration of the concrete surface was exacerbated by the nearly continuous leakage that flowed over the surface due to the condition of the wood flashboards. Because the river is heavily regulated, the flashboards are not released or replaced on any frequency, which results in a continuing increase in leakage. In addition, the soft surface of the concrete had allowed vegetation to grow, further increasing the freeze-thaw damage by promoting penetration of water into the concrete surface, and promoting erosion of the concrete surface. Again, because the river is highly regulated, there is infrequent and insufficient spillage over the flashboards in which to wash away the vegetation.

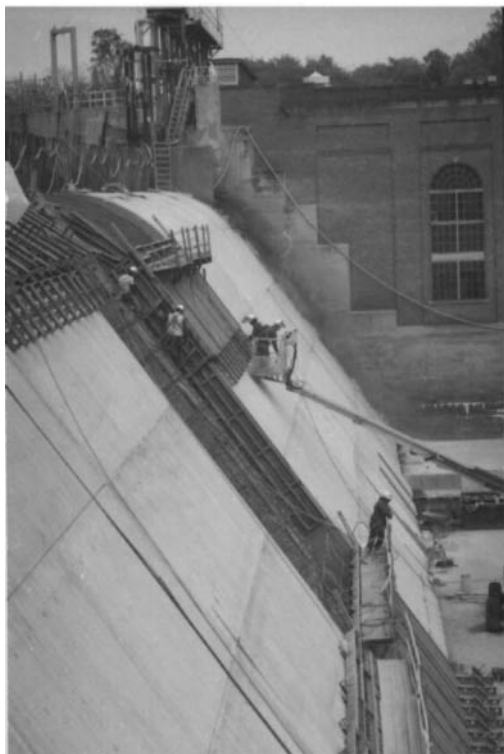
Figure 4.3-9 Rainbow Dam, Repairs
(courtesy of Kleinschmidt Associates)

To restore the condition of the spillway, the downstream surface was resurfaced with 36-inches of cast-in-place reinforced concrete (see Figure 4.3-9). The concrete was a 4,000-psi mix, with an air entraining admix to provide protection against freeze-thaw damage, and superplasticized to reduce the water to cement ratio. The life expectancy of a resurfacing overlay should be at least 50 years, and probably 75 years if appropriate measures are taken to address surface preparation, leakage, and freeze-thaw. While resurfacing overlays are normally 8 to 12 inches thick, the Owner elected to provide a heavier overlay at the Rainbow Dam to increase the stability of the spillway to meet the dam safety standards of the State of Connecticut. The cost of the stabilization was the incremental cost of the additional concrete needed (approximately 1,625 cy for the additional 24-inches of thickness).

The concrete overlay was mechanically fastened to the existing dam by the grouting of reinforcing dowels into the existing dam. Minimal grouting of leakage through the existing dam was performed; rather, the leakage was collected and piped through the concrete overlay. It was determined that it was better to let the minimal leakage continue from a known location rather than attempt to grout the leak, only to have it reappear in another location some days, or months, later. During placement of the concrete, the piping system allowed leakage to be passed through the fresh concrete without washing of cementitious materials.

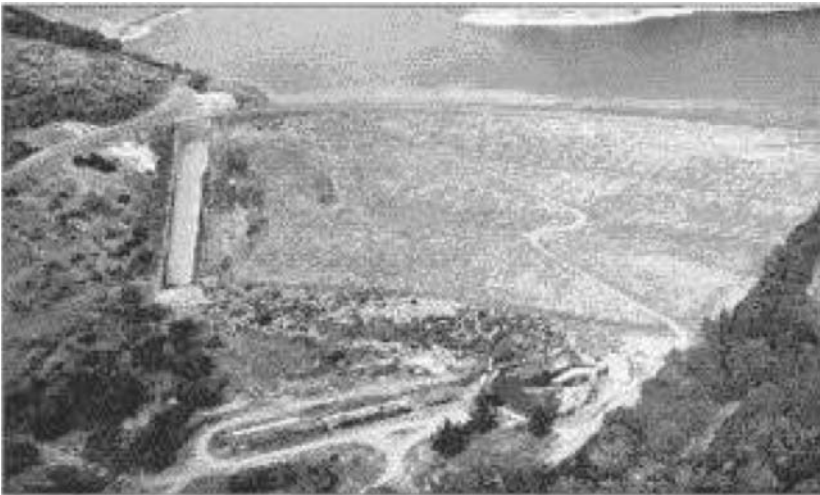
**Figure 4.3-13 Lopez Dam
(courtesy of MWH)**

Both the upstream and downstream shells have slopes of 3 horizontal to 1 vertical (3H:1V). The slopes include a 100-foot wide berm at elevation 450 feet on the upstream shell and a 140-foot wide berm at the same elevation on the downstream shell. The core extends to foundation rock, but the shells of the dam were founded on river alluvium, which has a maximum thickness of approximately 110 feet.

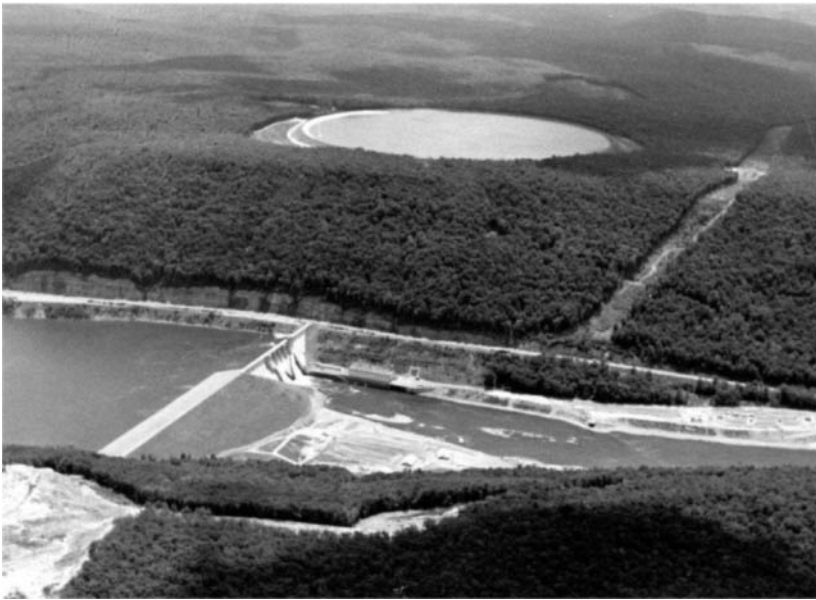
Figure 4.3-20 Seneca Pumped-Storage Project
(courtesy of MWH)

The 435-MW Seneca Pumped Storage Station is located on the Allegheny River in the Allegheny National Forest approximately nine miles east of Warren, Pennsylvania. The project is owned and operated by Cleveland Electric Illuminating, a FirstEnergy Company. The project uses the United States Army Corps of Engineers' Allegheny Reservoir, formed by the 179-foot-high Kinzua Dam, for the lower reservoir. The upper reservoir is located on a sandstone plateau about 800 feet above the river and is formed by a circular ring dike about one-half mile in diameter. The reservoir ring dike varies from about 30 to 120 feet in height with inside slopes of 2H:1V and variable outside slopes. Material for the dike was obtained from excavation within the reservoir and consists of clayey to silty sands, weathered sandstone and sandstone rockfill. The project is used to generate daily peak power, resulting in daily water level fluctuations of up to 64 feet in the upper reservoir. An overview of the project is shown in Figure 4.3-18.

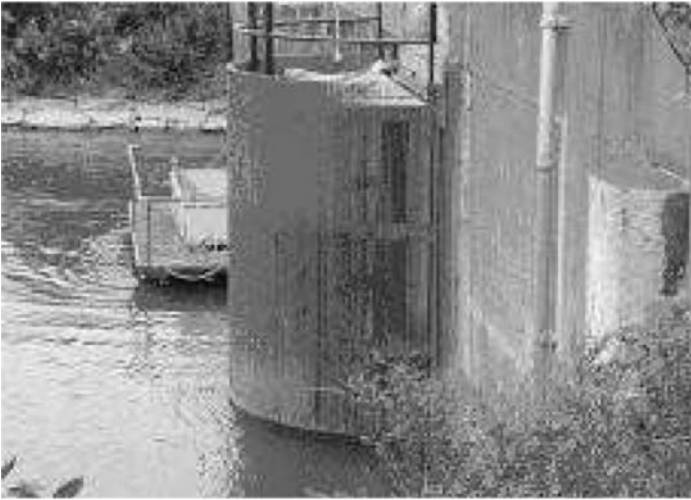
The rack bars are typically made out of vertical metal bars that are spaced to minimize head loss while still preventing larger debris from passing (see Figure 4.6-1). Normally the metal bars are carbon steel, but stainless and aluminum have also been used. Racks are also constructed of fiberglass or plastic, and have been constructed of wood. The bars are connected together by bolting or welding to form panels that span across the upstream face of the opening to the intake structure.

**Figure 4.6-1 Trash Rack at Bonneville Hydroelectric
(courtesy of Portland District, USACE)**

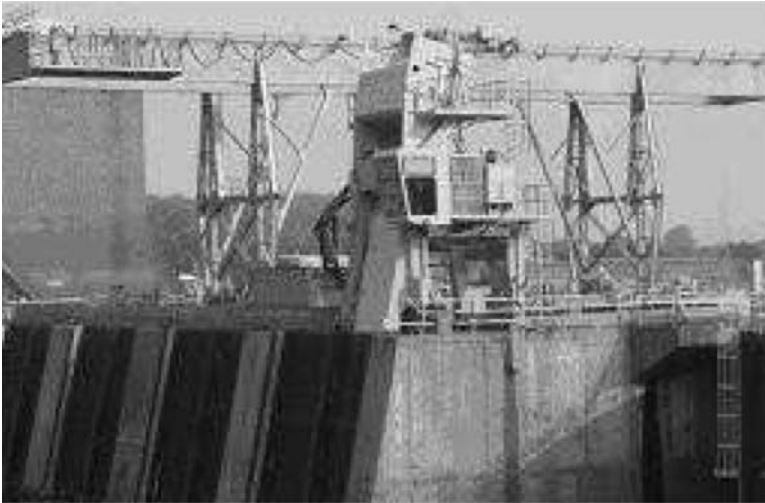
Figure 4.7-1 Racine Trash Rake
(courtesy of AEP)

To resolve these problems an automated trash rake system was installed. The new trash rake travels on rails across the intake deck. The rake head is attached to cables (hoist and carriage type rake), which lower the rake head to the bottom of the trash rack (see Figure 4.7-1). One of the cables attached to the rake head is used to rotate the rake head. When the rake head reaches the bottom of the racks, the cable is released, allowing the rake head to rotate, clamping the trash against the racks as it pulls up the racks, and dumping it into a trough. Man-made debris is removed from

the trough and the natural material is sluiced back to the river on the downstream side of the powerhouse. The trash racks are made up of eight, 11 foot wide sections. The rake is programmed to travel up and down one section of the racks twice and then move to the next section, and the process is repeated until all eight racks are cleaned. It takes approximately 30 minutes for the rake to set up and clean all eight sections of rack. The trash rake can be set to run continuously or at timed intervals. The project currently operates the trash rake on a timed interval, adjusting the time based on river conditions and the season.

The biggest problem encountered with the rake is that the designers underestimated the size of the debris being removed. During the removal of large tree limbs, the limbs could extend above the limit switch (shut-off switch) without tripping the machine off. When this happens the machine keeps operating allowing the portion of the tree limbs extending above the switch to hit the upper section of the machine causing damage. This problem was corrected by adding guard plates to the upper section of the machine.

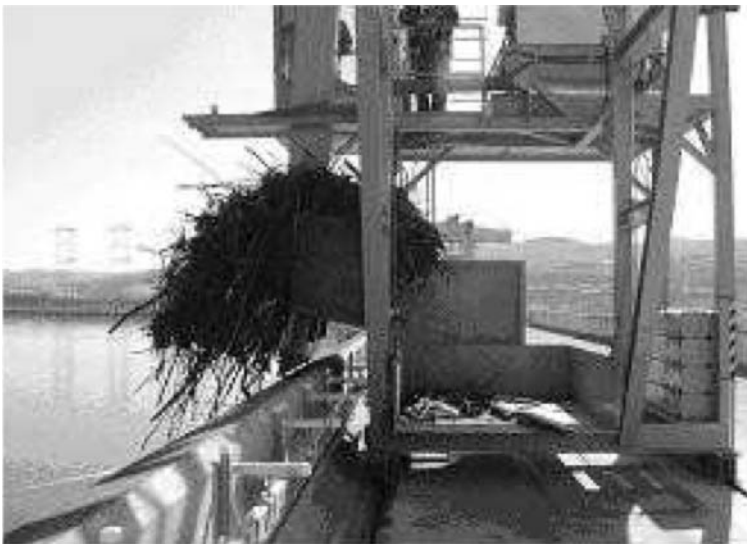
Figure 4.7-2 Trash Rake at Dalles North Shore
(courtesy of Portland District, USACE)

A new automated trash rake, with a superstructure mounted on rails, was procured. The trash rake (hydraulic, telescoping boom type) is lowered and raised by two opposing hydraulic cylinders (see Figure 4.7-2). An additional hydraulic cylinder is used to force the rake head against the trash rack. A two-man crew is required, consisting of an operator and a truck driver. The rake is self-positioning, and dumps into a debris container mounted on the rake structure. The container is automatically dumped into the same truck the prior system used. The new raking system can be safely operated at night, and allows the AWS to remain in operation during raking cycles.

The controls are set so the rake makes one pass automatically across the entire intake. There is a sensor, which measures differential pressure in the intake or the rake can be operated manually. Although there have not been any complaints with the basic operation of the rake, the major complaint has been with the layout. The layout of the access ladder exposes the operator to passing vehicular traffic and the hopper is awkward for unloading into a dump truck.

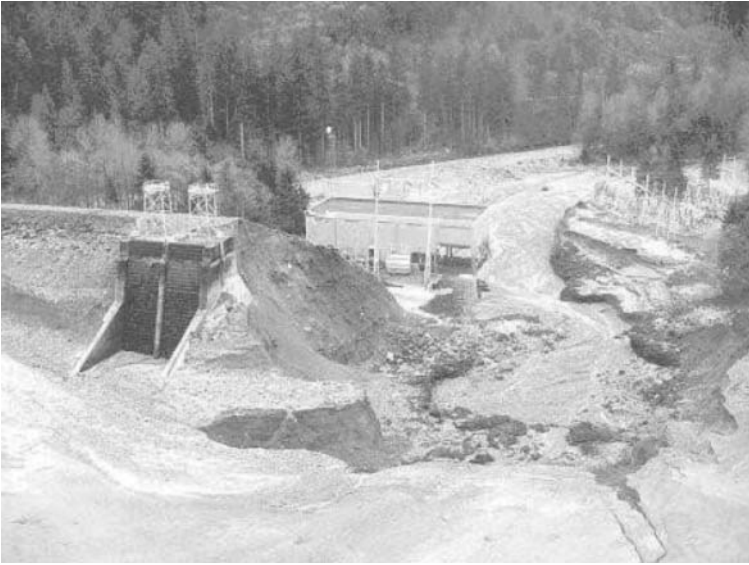
Figure 5.2-1 Canal Failure
(courtesy of FERC)

An example of the catastrophic effects a canal failure can have on the entire project is illustrated by the Swift 2 Power Canal Failure. In that case, the embankment section adjacent to the intakes for the power penstocks failed leading to uncontrolled release of the waters within the power canal (Figure 5.2-1). This uncontrolled release resulted in the inundation of the powerhouse with water and debris, undermining of the foundation, destruction of the facility's electrical equipment, and severe damage to the switchyard.

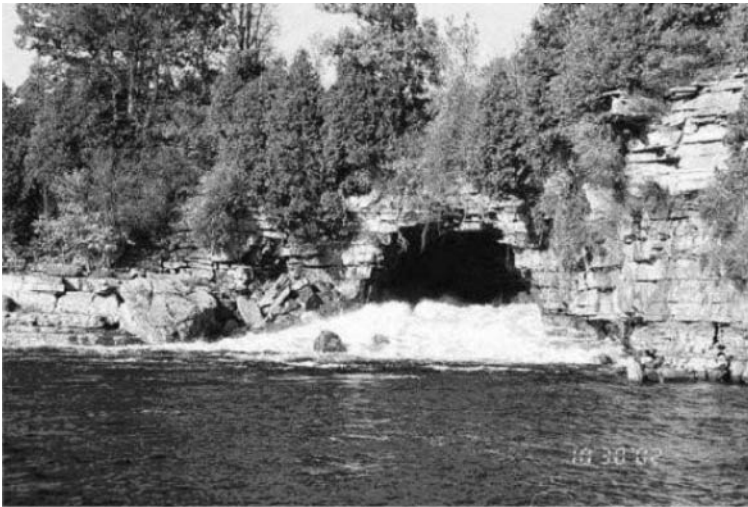
**Figure 5.2-2 Glen Park Hydroelectric Project
(courtesy of Kleinschmidt Associates)**

Canals are also constructed by being excavated from rock, and failure of a canal wall can occur due to leakage and ensuing displacement of the natural stone blocks, as occurred in the unlined rock canal of the Glen Park Hydroelectric Project in Watertown, NY (Figure 5.2-2).

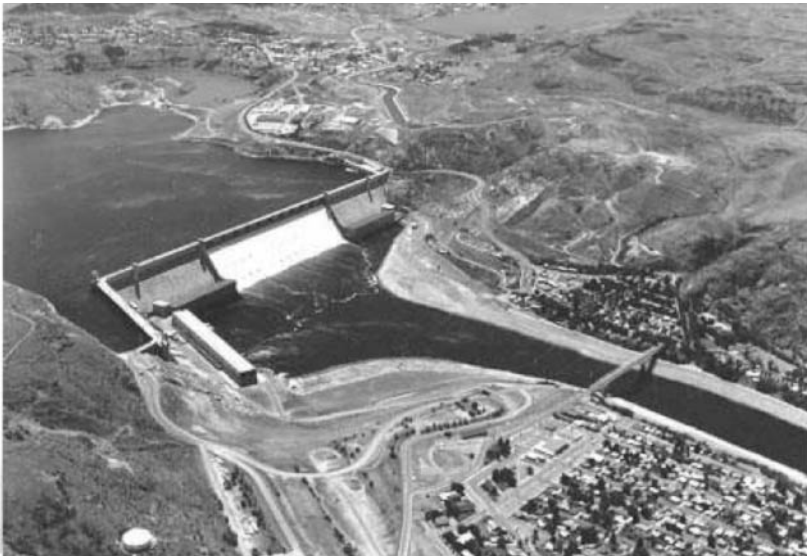
**Figure 5.2-3 Grand Coulee Forebay Dam and Third Powerplant
(courtesy of USBR website)**

When the Grand Coulee Project was originally constructed, it included provisions for the addition of third powerplant. The addition of this third powerplant however required the extension of the main dam, the extension being aptly labeled the Forebay Dam for the Third Powerplant (Figure 5.2-3).

The Forebay Dam, though actually an extension of the main Grand Coulee Dam, is a gravity structure over 200 feet high and more than 1,300 feet long that is constructed on a rock bench 270 feet above the downstream powerhouse. Placement of the dam atop this bench required extensive testing and studies to determine the stability of the foundation in which were included two major faults and five major joint sets.

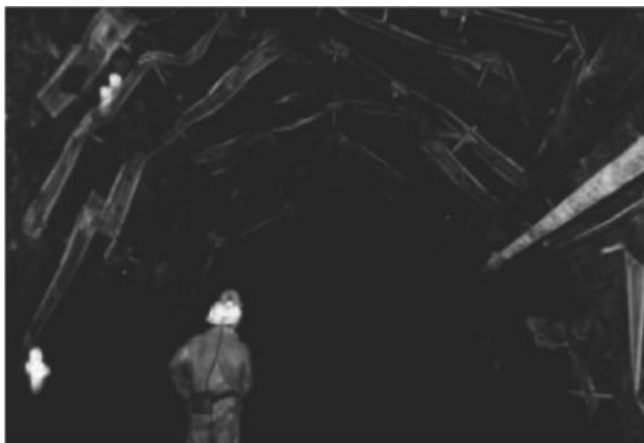
Figure 5.3-3 Power Creek
(courtesy of de Rubertis)

- Placing heavy steel sets with timber lagging between the flanges and backfill concrete behind the lagging in the worst ground.
- Installing galvanized, fully resin-anchored, pattern rockbolts (3 different patterns depending on the condition of the ground).
- Installing galvanized mine straps across weak areas.
- Installing weld wire fabric between rockbolts in raveling ground.
- Installing timber cribbing to support rock haunches that could not be effectively rockbolted.
- Shotcreting the entire back and ribs of the tunnel in all areas of permanent support. Shotcrete covered at least 75% of the tunnel area. A few tunnel sections required no permanent support.

After completing the permanent support, a 76-in diameter steel penstock was installed inside the tunnel. In areas of weak ground, the top of the steel penstock was covered with a protective layer of timber.

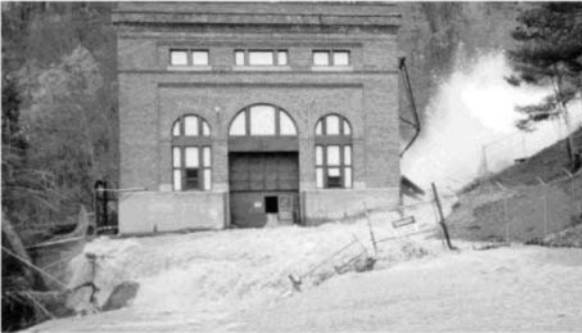
Figure 5.4-1 Schaghticoke Project
Uncontrolled discharge due to the failure of one of the 6 foot diameter penstocks upstream of the powerhouse
(courtesy of Brookfield Power New York)

During a normal shutdown of Unit 3 in 1998, the penstock for Unit 3 experienced a complete failure 30 feet above the powerhouse, as well as the scroll case manhole cover inside the powerhouse. This resulted in a stream of water under 150 feet head blasting the side of the powerhouse and eroding the surrounding embankments. The failed manhole cover resulted in as much as 4 feet of water flooding the interior, tripping the other operating units, and severely damaging almost all electrical and mechanical equipment.

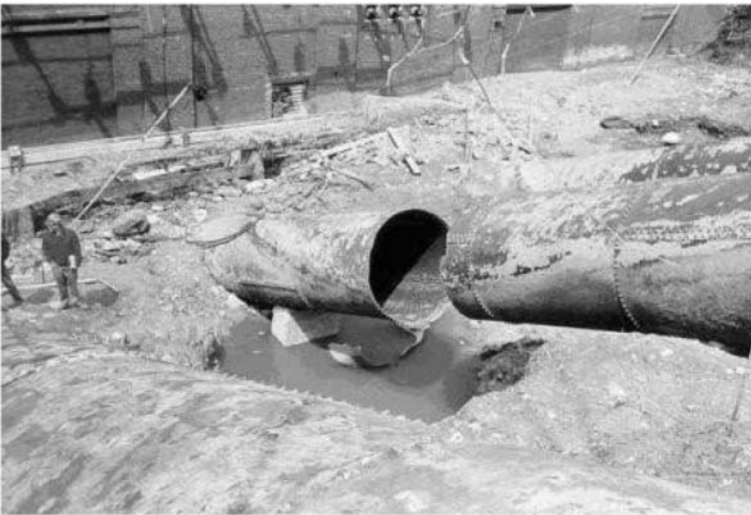
Figure 5.4-2 Schaghticoke Project
Failed Section of Penstock
(courtesy of Brookfield Power New York)

Results showed that the failed Unit 3 penstock was severely weakened in two areas by localized corrosion. The routine shutdown of the unit caused a series of pressure pulses that ruptured the penstock at the weakened area. Flow through the rupture caused turbulence and resonance that resulted in cracking from fatigue, until complete separation occurred. The other three units were in good enough condition to return to service, but tests showed the 12.5-foot diameter pipeline needed significant repairs.

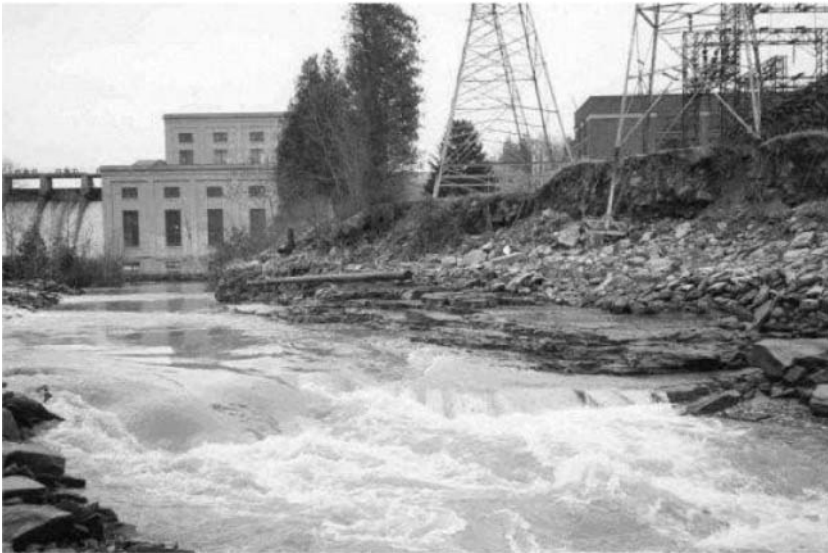
Figure 5.5-1 Shoreline Erosion That Resulted From High River Flows
(courtesy of Brookfield Power New York)

erosion or transport continues, the tailrace cross-section increases and water elevations reduce (see Figure 5.5-1).

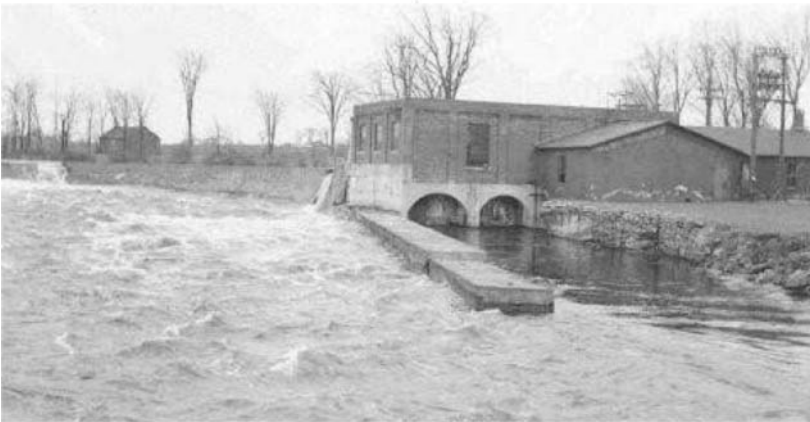
Figure 5.5-2 Tailrace Training Wall Separating the River from the Tailrace (courtesy of Brookfield Power New York)

Some facilities have relatively short concrete walls (less than a few hundred feet long), known as training walls, separating the river from the tailrace channel (see Figure 5.5-2). Their original design function was to direct river flow away from the tailrace while taking advantage of the natural slope of the river to provide a lower tailwater elevation (and increased gross head) at the powerhouse and at the same time preventing debris from being deposited in the tailrace from the river. These walls are often neglected in the planning of maintenance programs, and when they deteriorate, water and debris can enter the tailrace, adversely impacting the tailwater elevation (and gross head) at the powerhouse.

The original purpose of the training wall was to provide for separation between the main river and the tailrace (see Figure 5.5-2). This wall kept debris out of the tailrace and also allowed for a lower than normal tailwater elevation at the powerhouse that produced a larger gross head for generation purposes. In recent years, the training wall was showing signs of significant concrete deterioration. There was of holes that penetrated through the entire thickness of the wall and concrete deterioration was evident throughout its length.

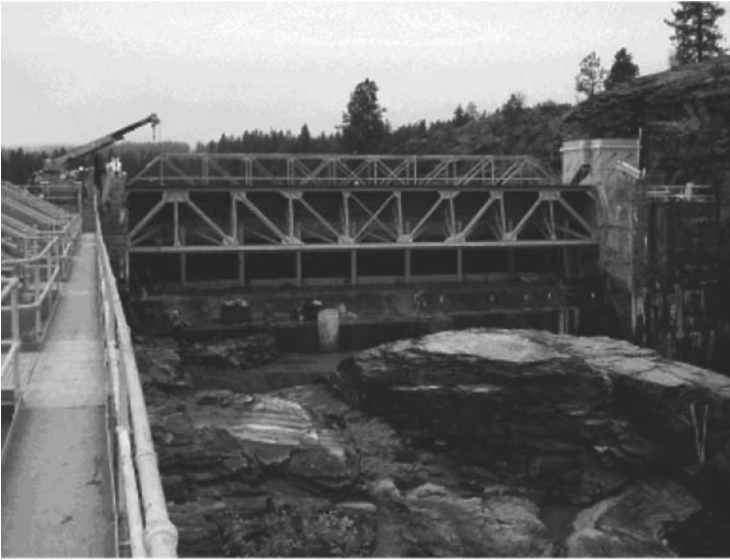
Figure 6.2-4 Post Falls Dam – Sector Gate Spillway
(courtesy of MWH)

The rolling sector gate is a rather unique gate, having qualities of both a radial gate and a roller dam gate. The gate functions in a manner similar to a radial gate, but instead of pivoting about a single axis (trunnion), the ends of the gates have large diaphragms with geared perimeters that engage pier-mounted racks on either pier. As the gate is raised with a 42-ton chain hoist, the gate "rolls" up these tracks.

Due to the age of the rolling sector gate, and a change in the loading conditions that resulted from a previous 1.5-ft. pool raise, a condition assessment and structural analysis was performed in 2001. It concluded that the gate needed additional structural reinforcement to bring the gate up to modern standards. In addition, the gate required general rehabilitation, including painting and seal replacement, and the hoist required reconditioning. To make the required structural modifications, the gate would have to be unloaded.

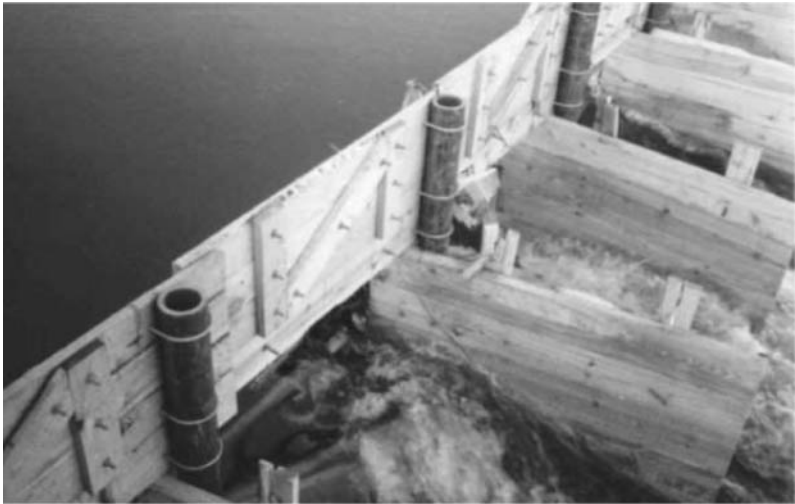
Figure 6.4-2 Photo of a Two Level Manually Trippable Flashboard System with the First (Lower) Level Tripped (courtesy of Brookfield Power New York)

Figures 6.4-1 and 6.4-2 show a somewhat more sophisticated system that was designed to be tripped from both ends of the spillway, with two separate vertical levels that can be tripped independently, depending on level of flows. Resetting the boards is accomplished by lowering the impoundment below the spillway crest and manually resetting the boards. The type of flashboard arrangement as shown in Figures 6.4-1 and 6.4-2 is generally suitable for vertical heights of less than 5 feet.

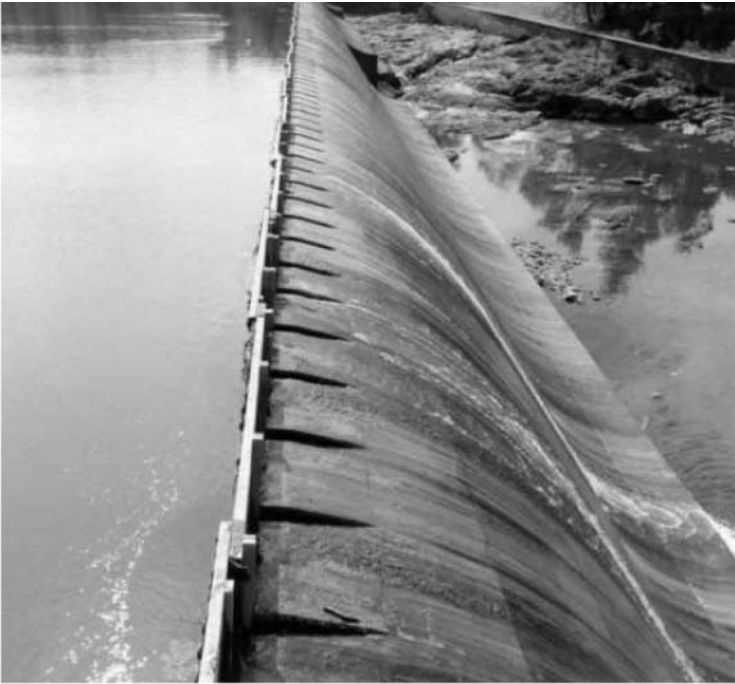
Figure 6.4-4 Photo Showing the Shear Pin Trippable Flashboard System (courtesy of Brookfield Power New York)

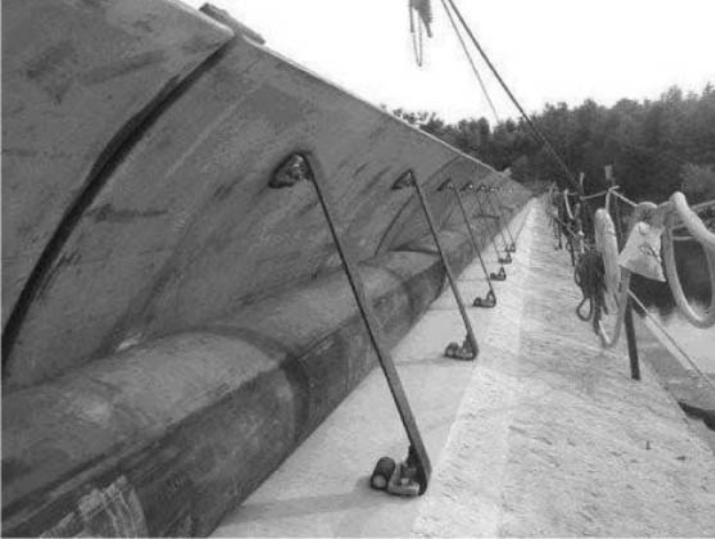
The inflatable flashboard system consisted of individual rubber air bladders that are armored on the upstream side with 5/8 inch thick stainless steel plates. The total height of the system, when fully inflated, is 3 feet. The economics for this project provided for a 3 year payback period based solely on the increase in generation. The inflatable flashboard system offered other benefits. For example, part of the design criteria, mandated by the regulatory agencies, was the ability to pass 800 cfs for

Figure 6.4-6 Downstream Side of Rubber Dam
(courtesy of Brookfield Power New York)

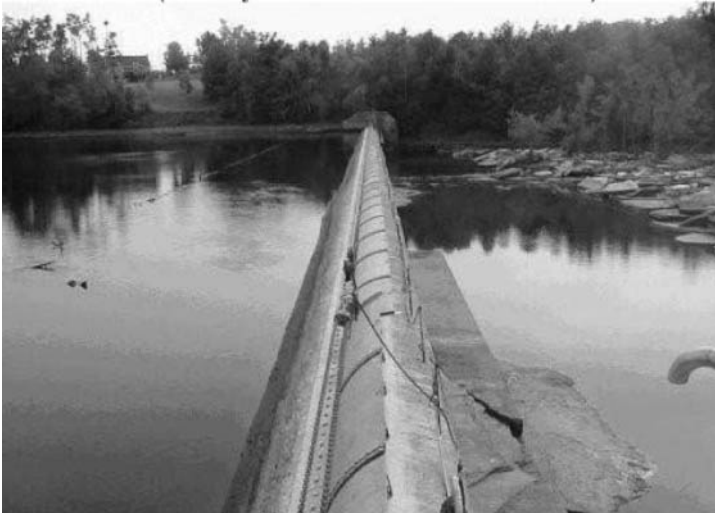
Figure 6.4-7 Upstream Side of Rubber Dam
(courtesy of Brookfield Power New York)

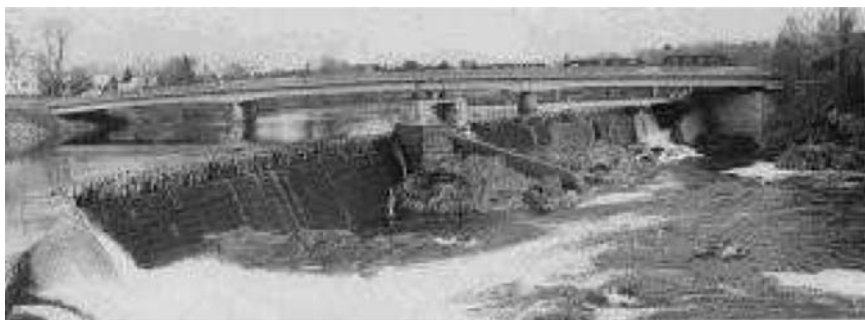
The Anson Hydroelectric Project is located in Madison, ME. The 1929 vintage project generates 9 MW at 23 feet of head. The project is one of two that provides electric power and water to the owner's paper mill. The concrete gravity and stone masonry dam is 630 feet long and includes three sections of flashboard-regulated spillway totaling 528 linear feet. The flashboards are one-inch thick wood planks, 4.1 feet high, and supported vertically by 2-inch diameter steel pins (Figure 6.4-8). The project also included three deep gates used to sluice trash and debris from the entrance of the powerhouse forebay.

**Figure 6.4-8 Anson Dam Original Flashboards Configuration
(courtesy of Kleinschmidt)**

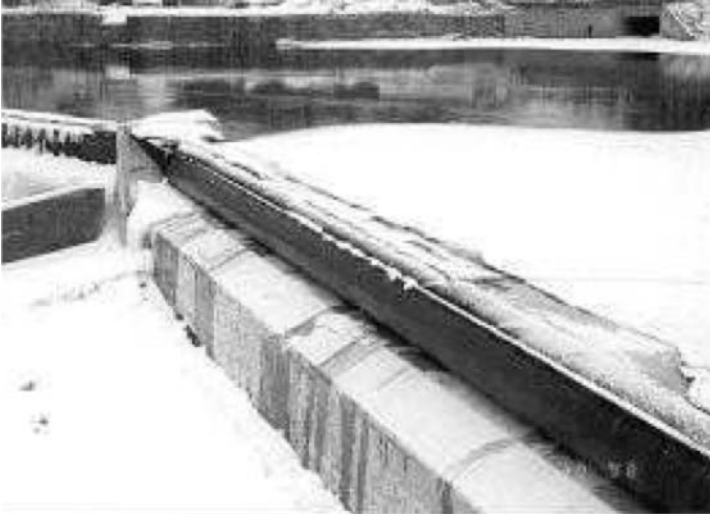
The inflatable rubber gate and the inflatable rubber dam on each section of the spillway can be operated separately, and allow the owner to maintain a constant impoundment level for flows up to 30,000 cfs, equivalent to the 3-year flow. For higher flows, the rubber gate and rubber dams are deflated and the crest level of the dam is the same as when flashboards were used.

Figure 6.4-9 Anson Dam Rubber Dam
(courtesy of Kleinschmidt Associates)

was added across each of the spillways of the three sections of dam (Figure 6.4-9). The rubber gate and dam were selected over steel gates due to their simplicity of design, the ability to open (deflate) the gate without need of electric power, and the absence of materials or fluids that may create an environmental concern downstream. When deflated, the rubber dam also provided an unrestricted spillway capable of discharging any volume or size of debris or ice. The rubber dam also fitted well with the work of resurfacing the spillway dams to repair concrete deterioration, by not requiring any modification to the dam structure, as would be required to accommodate steel gates.

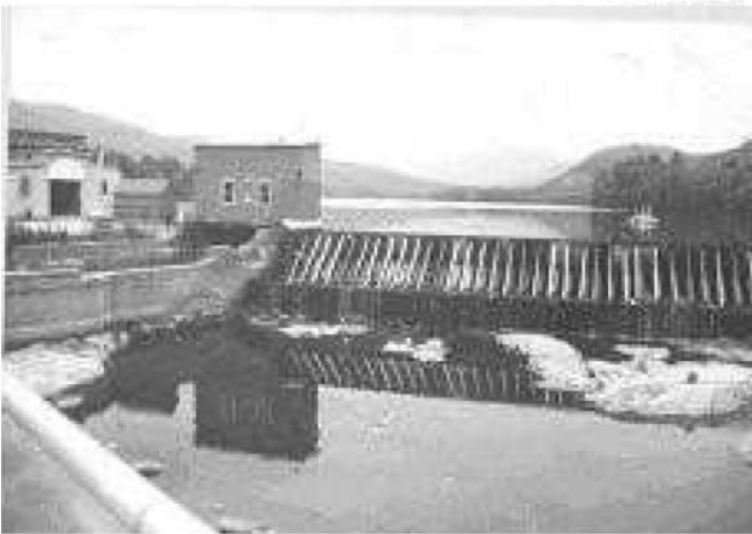
**Figure 6.4-10 Shelburne Dam Original Flashboard Configuration
(courtesy of Kleinschmidt Associates)**

The dam consisted of a 186 ft long section of 10 ft high vertical flashboards on a three to five foot high timber crib sill. Other discharge capacity was provided by four 6 ft wide sluice gates of varying height, and one 19 ft wide by 13.5 ft high log flume gate used as a sluice gate. The flashboards were tripped manually, using a cable winch to pull the support struts to control the release and minimize the loss of flashboards. The flashboards were divided into an upper and lower section, and each section was divided in two, allowing the flashboards to be tripped in increments of 25% (Figure 6.4-10).

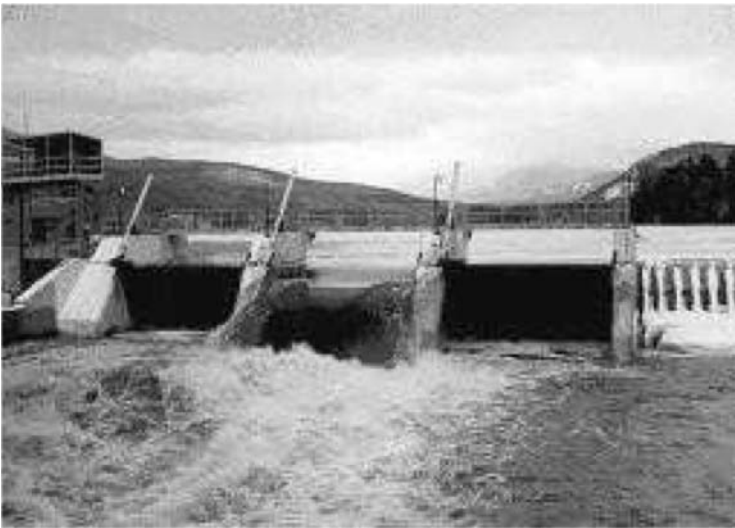
Figure 6.4-11 Shelburne Dam New Crest Gates
(courtesy of Kleinschmidt Associates)

In 1990, 110 feet of the flashboard dam was replaced with three 25 foot wide by 10 foot high hydraulically operated crest gates. The remaining 76 feet of dam was rebuilt by replacing the timber crib sill with concrete, and installing new 10 foot high vertical flashboards that were similar to those currently used at the dam (Figure 6.4-11). Several changes occurred, which allowed the gates to be installed at this time but not in the past. These included the replacement of the four sluice gates and the
